**Fourth
Five-Year Review Report**

**Vogel Paint and Wax Company Superfund Site
Sioux County
Maurice, Iowa**

September 2014

**Region 7
United States Environmental Protection Agency
Lenexa, Kansas**

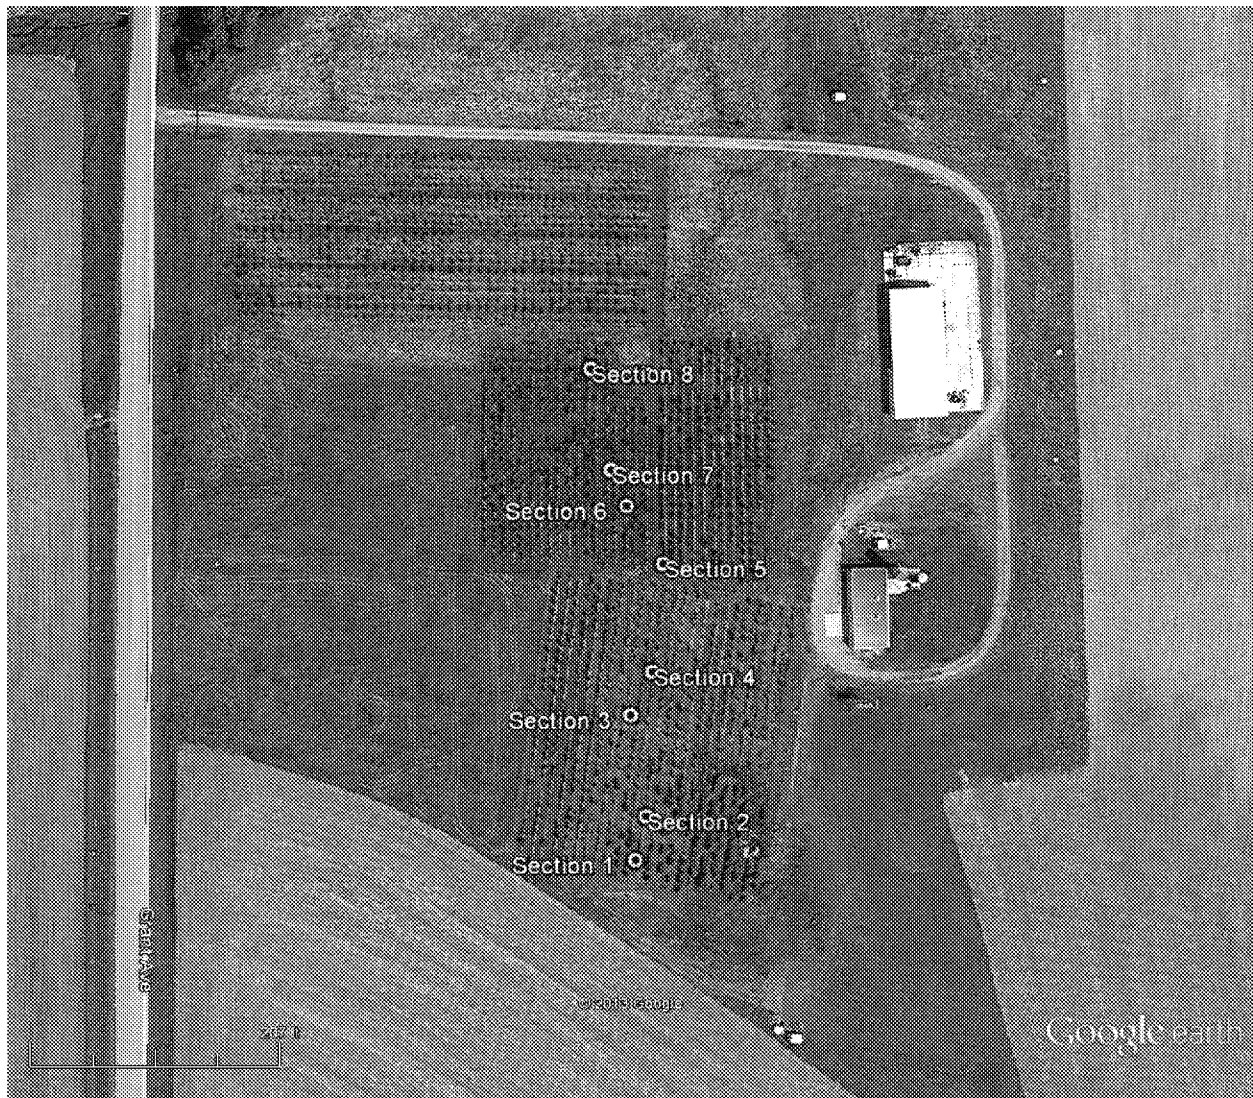
Vogel's - Approximate locations of tree core samples. Samples collected 11/20/2013

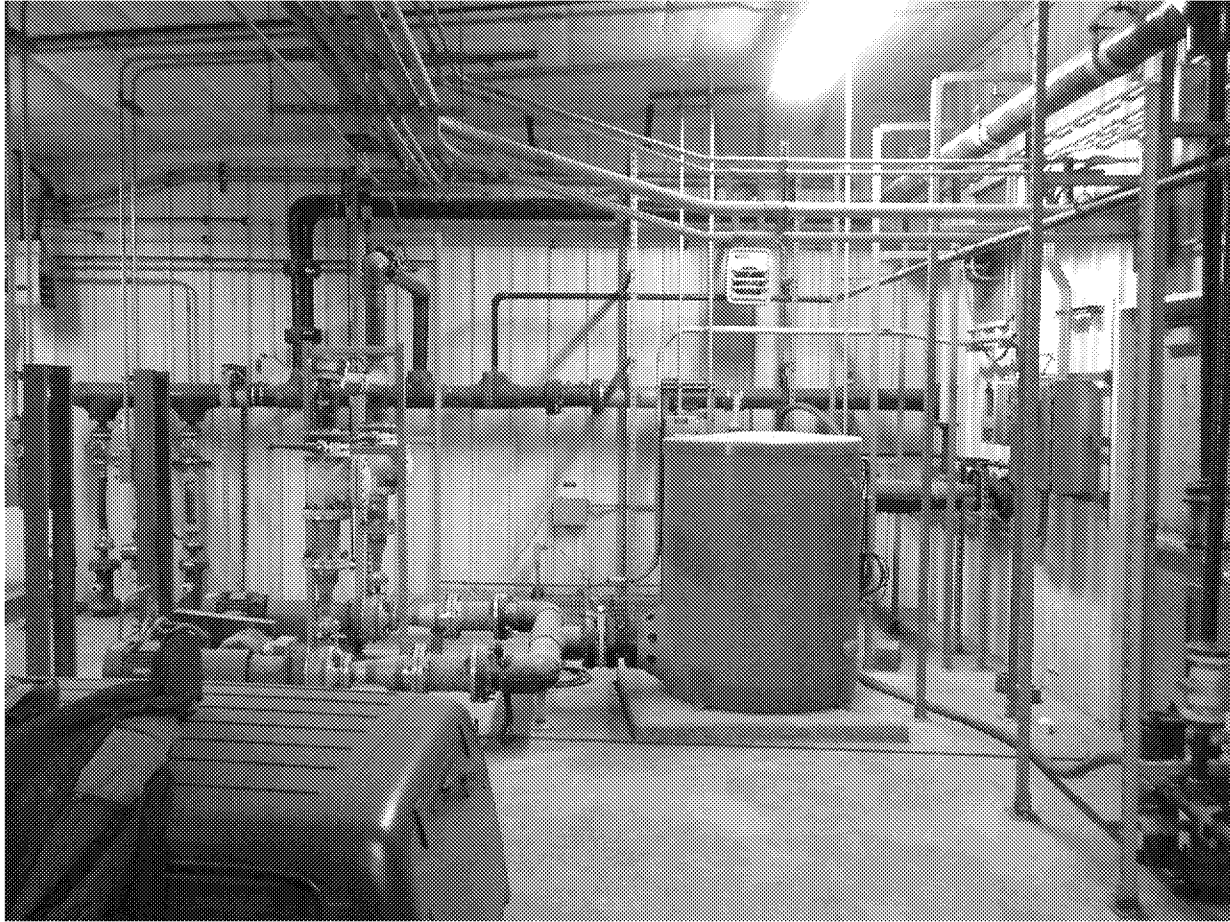
Photo 1: Interior pump, piping, and equalization tank for the groundwater treatment plant. System feeds into air stripper tower located behind the wall to the right of the photo.

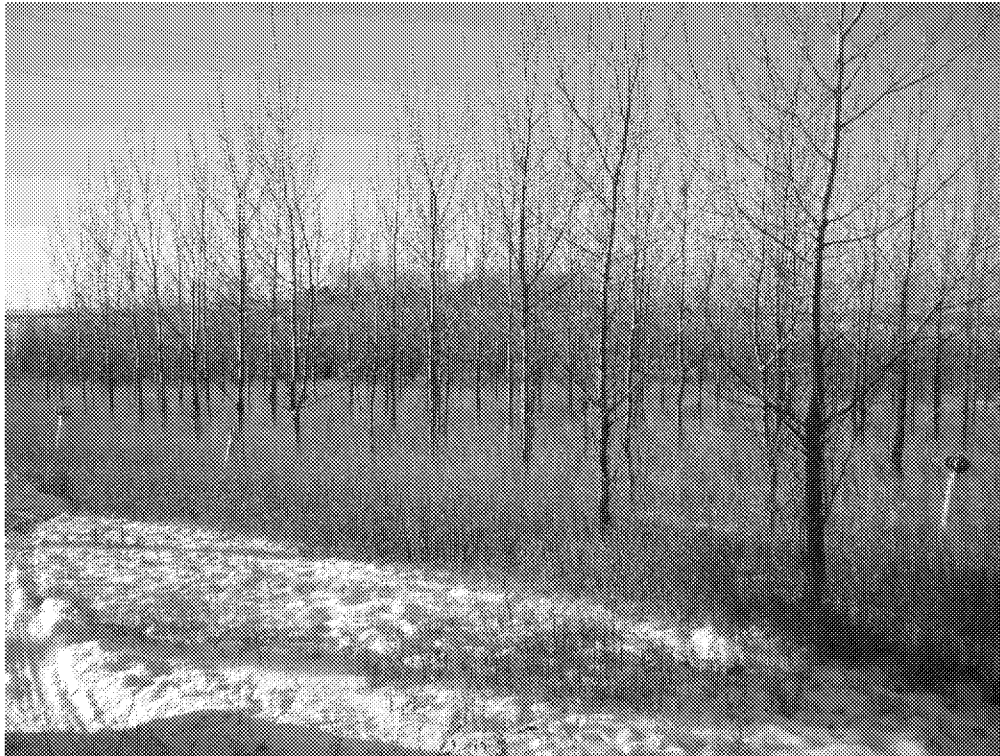
Photo 2: Typical photo of phytoremediation trees and soil vents. Electrical overhead lines are visible from upper left hand corner of photo. Photo taken from outside the west side of the groundwater treatment plant facing south-by-southwest.

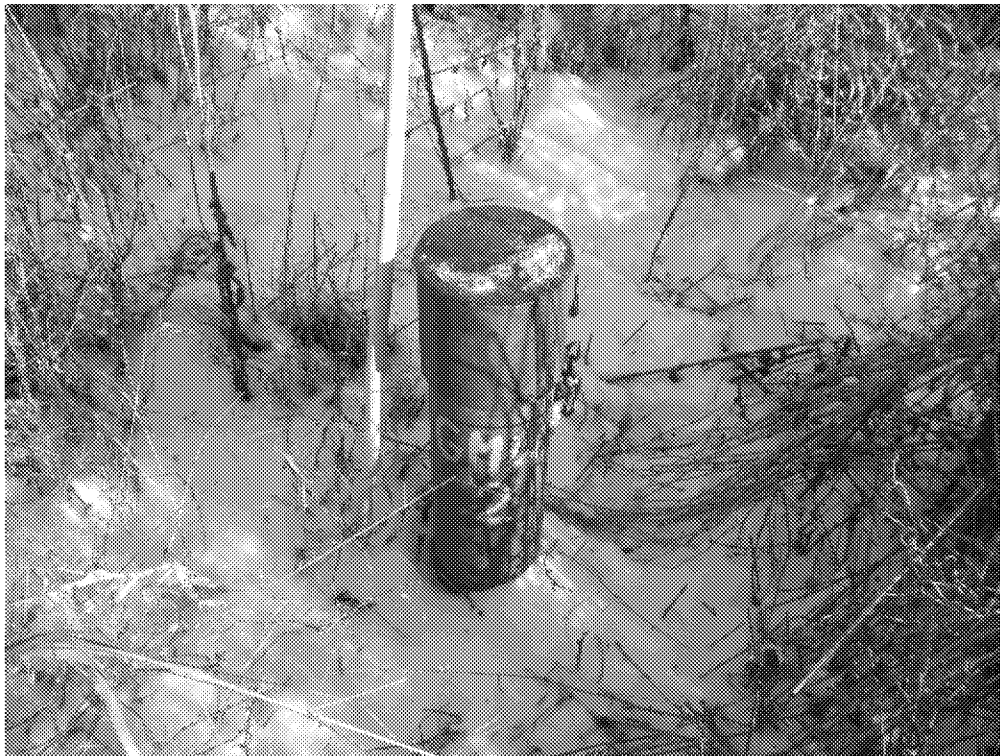
Photo 3: GMW-2, typical photo of condition of monitoring wells at the site.

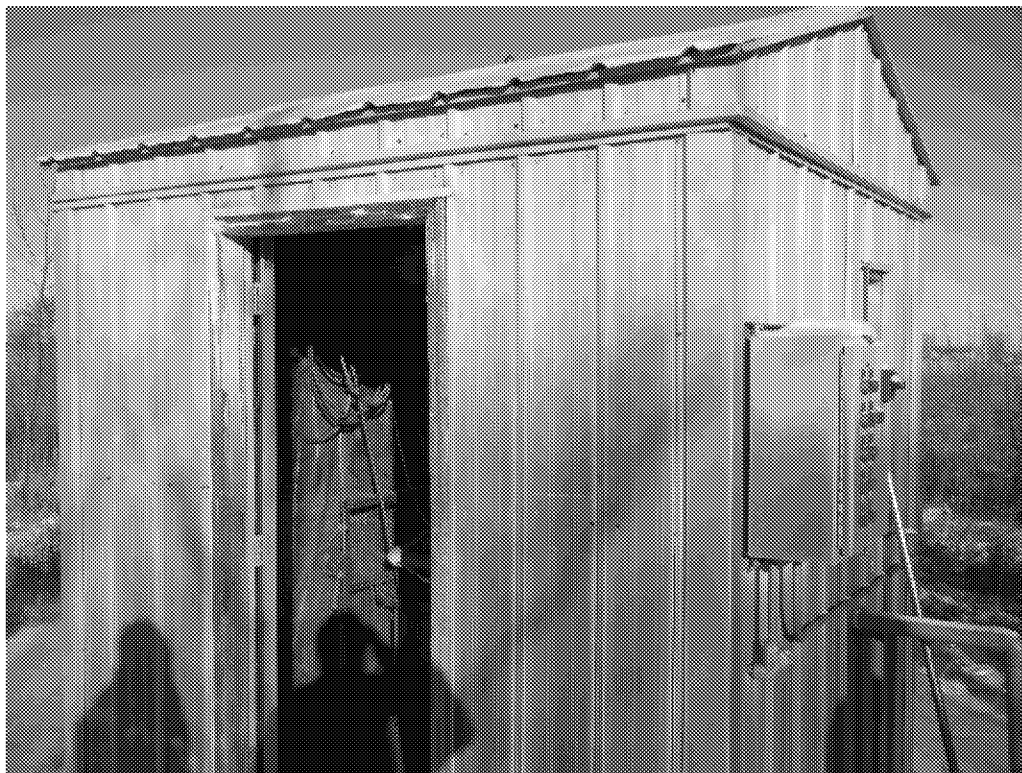
Photo 4: Extraction well house, typical exterior.

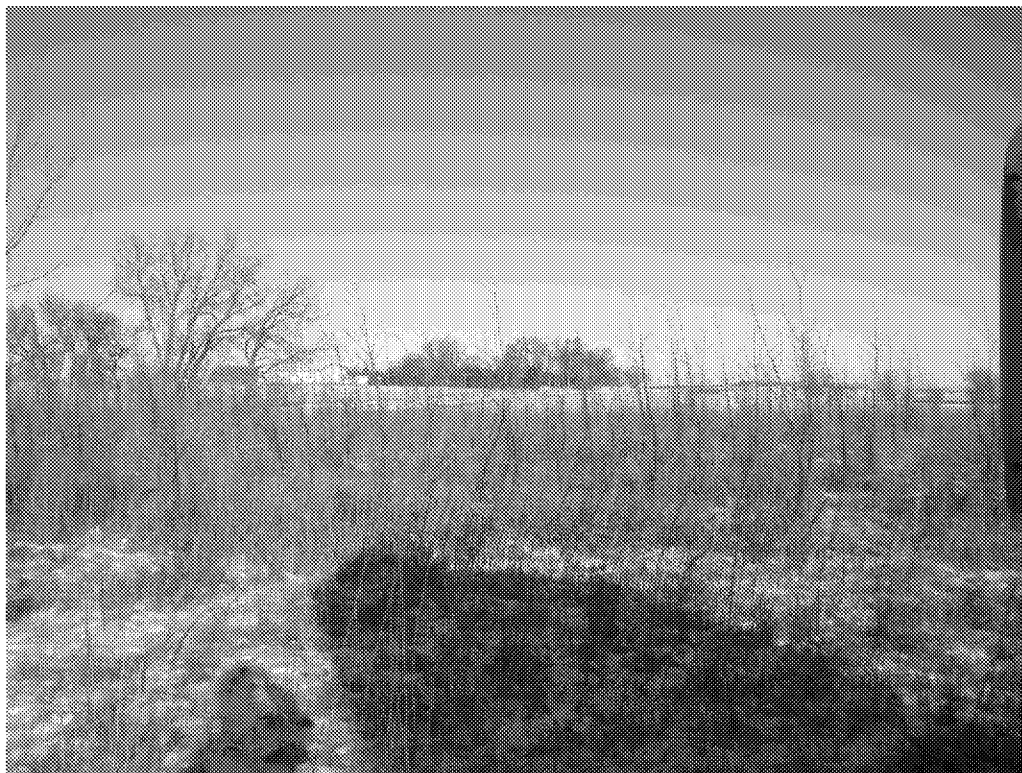
Photo 6: Phytoremediation trees located in northwest portion of site, these are the most recently planted trees and were not mature enough for core sampling. Photo taken from south facing northwest.

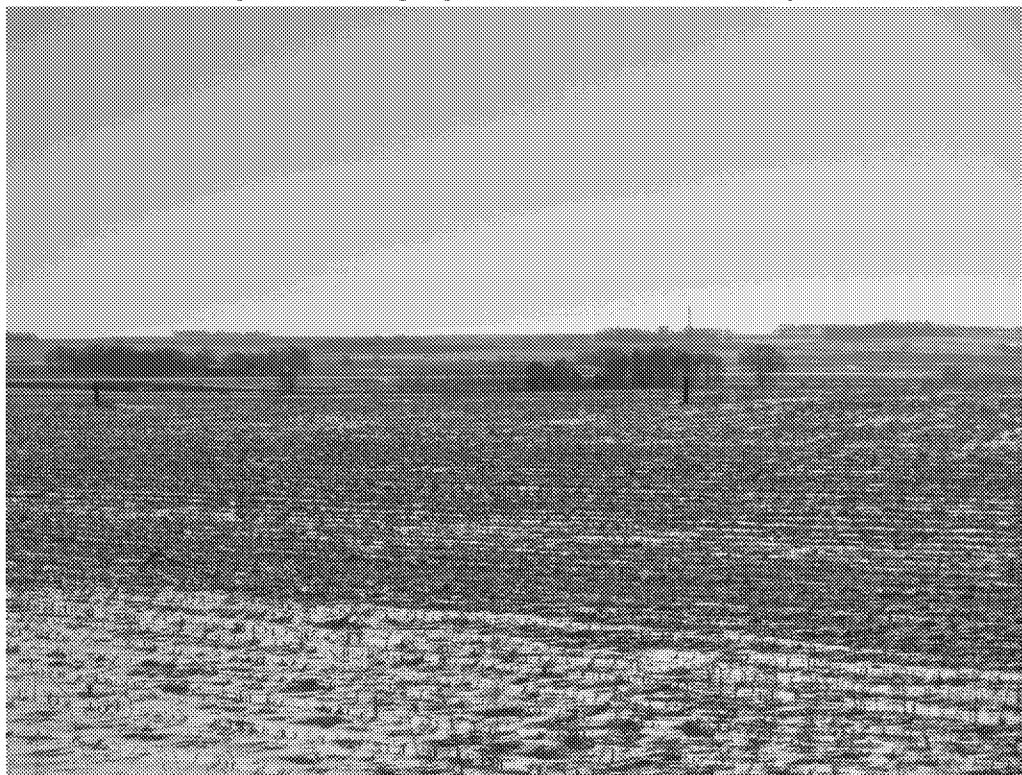
Photo 7: Two off-site wells located on property to south of the site.

Groundwater concentrations are increasing in off-site wells and as a result, EPA is recommending the groundwater treatment system be reconstructed or restarted to contain the groundwater plume. If the PRP intends to use phytoremediation as a component of the groundwater cleanup, data should be collected to evaluate if the technology is an effective means of addressing the groundwater contamination at the site.

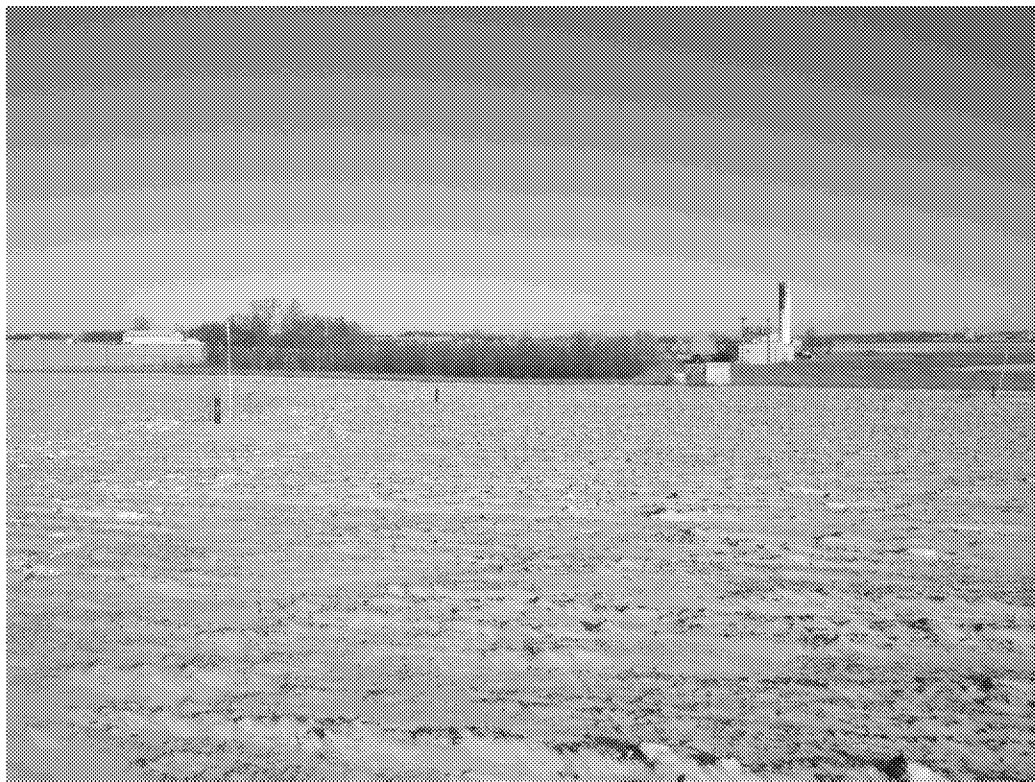
Photo 8: Photo of site from southern site boundary facing towards the groundwater treatment plant and phytoremediation trees to the north.

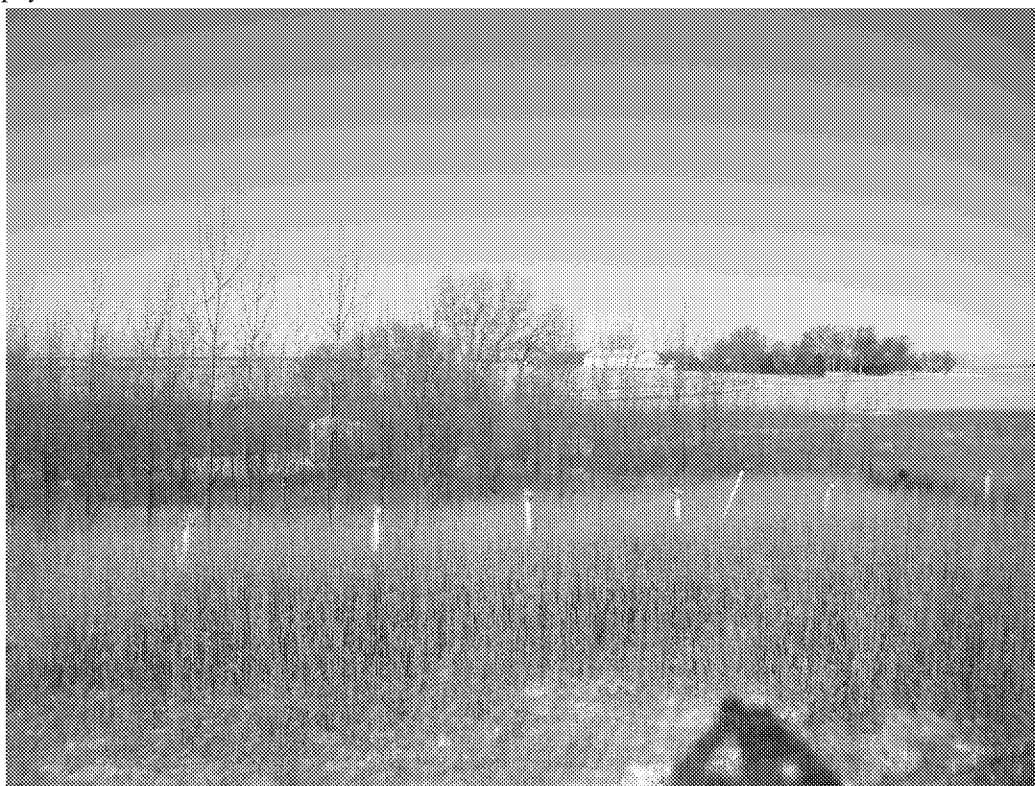
Photo 9: Photo of site from south of groundwater treatment plant facing west-by-northwest. Photo foreground shows the soil vents, background is the phytoremediation trees and extraction well house shown in Photo 4.

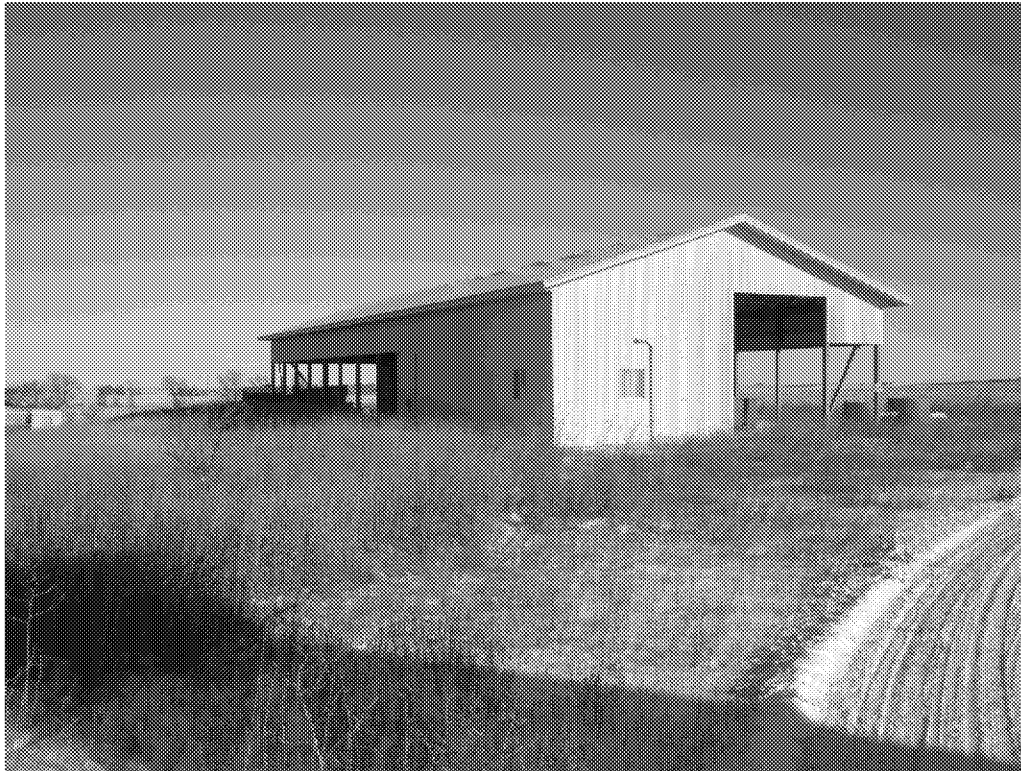
Photo 10: Concrete slab-on-grade equipment cover for farming equipment located north of the groundwater treatment plant. The only other structure on the site besides the treatment plant and extraction well houses.

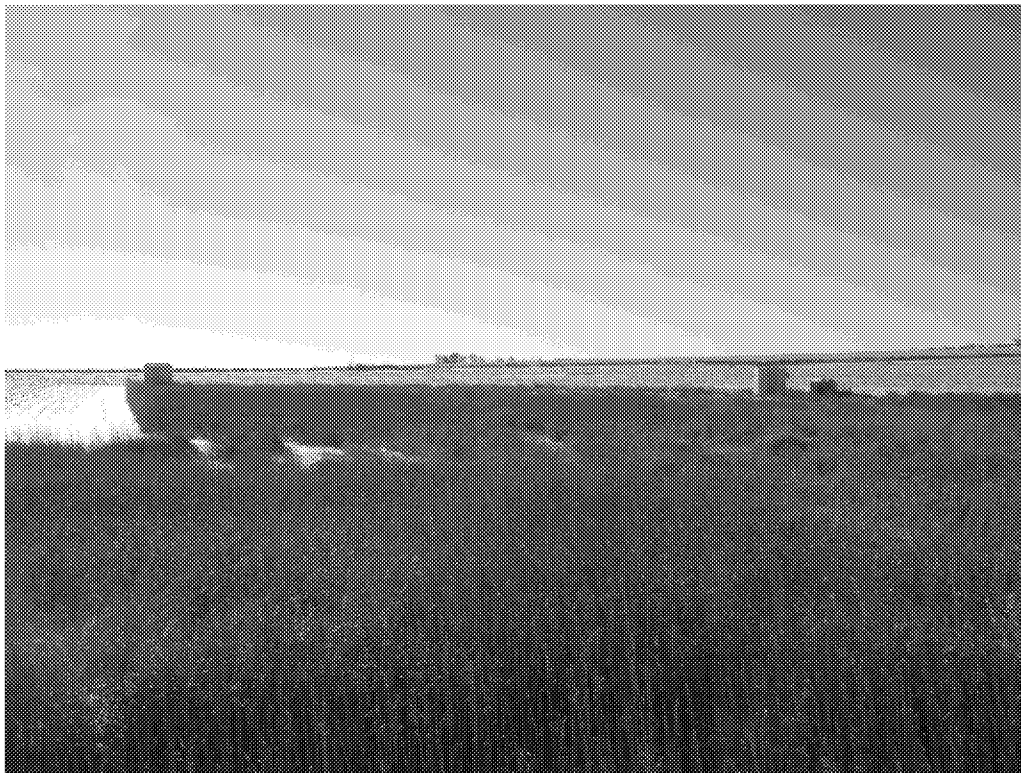
Photo 11: Two extraction well houses located on eastern portion of the site. Photo taken from east side of groundwater treatment plant facing east.

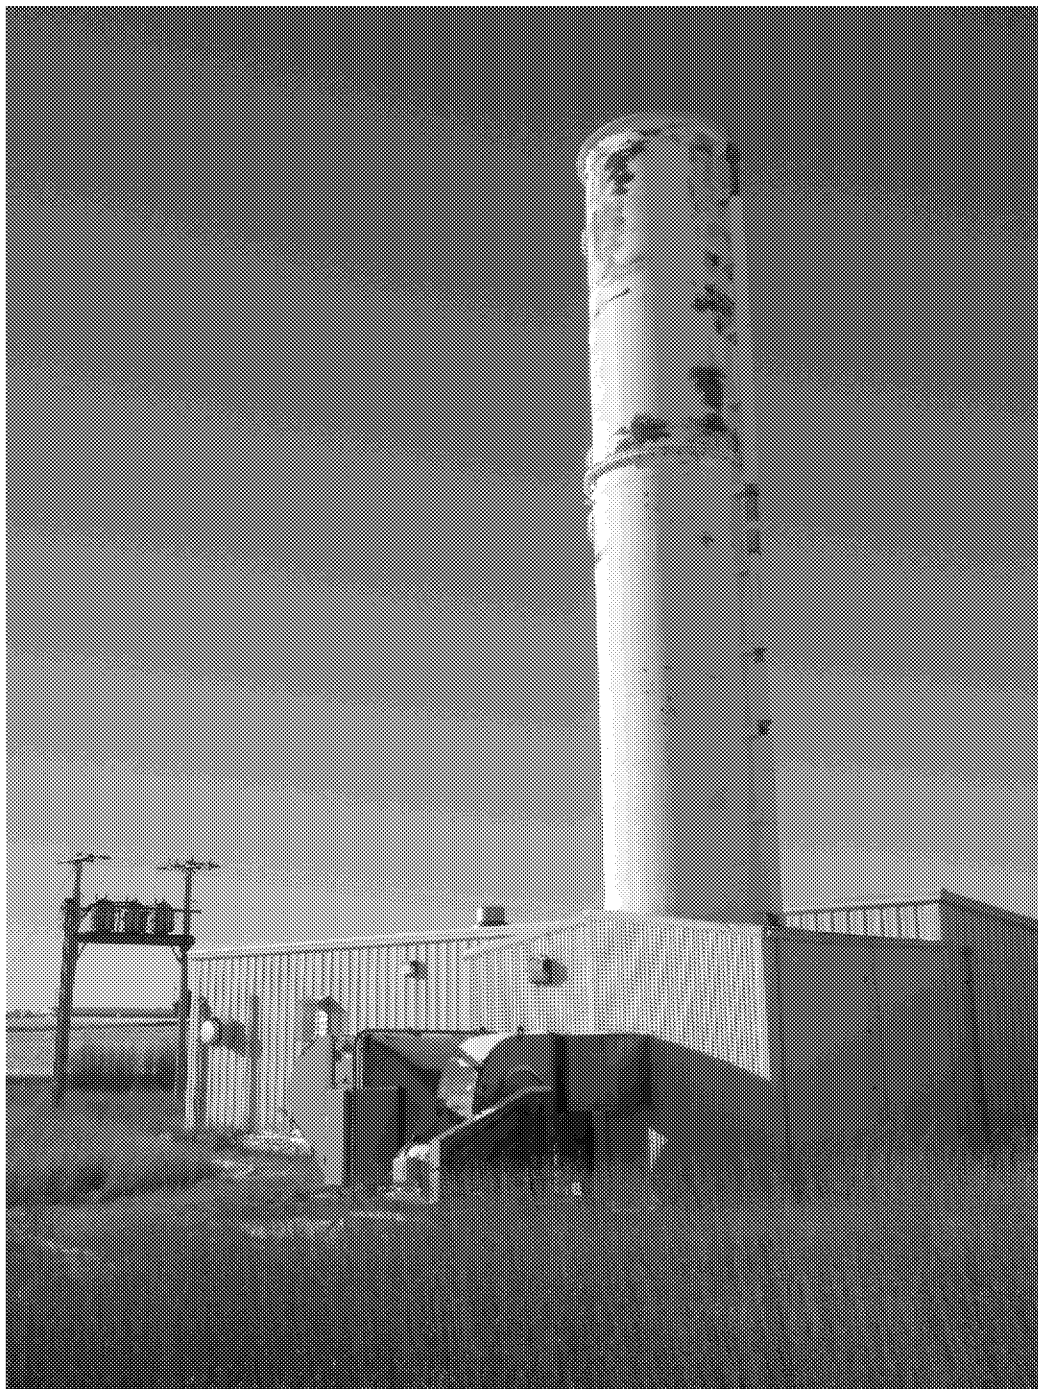
Photo 12: Eastern side of groundwater treatment plant, including air stripper tower. Blower-heater equipment for the air stripper is in the foreground. Incoming power lines to the treatment plant are located on the left side of the photo.
